SERVICE BULLETIN

TR-2500

#858

SUBJECT: TR-2500 RX IMD Improvement

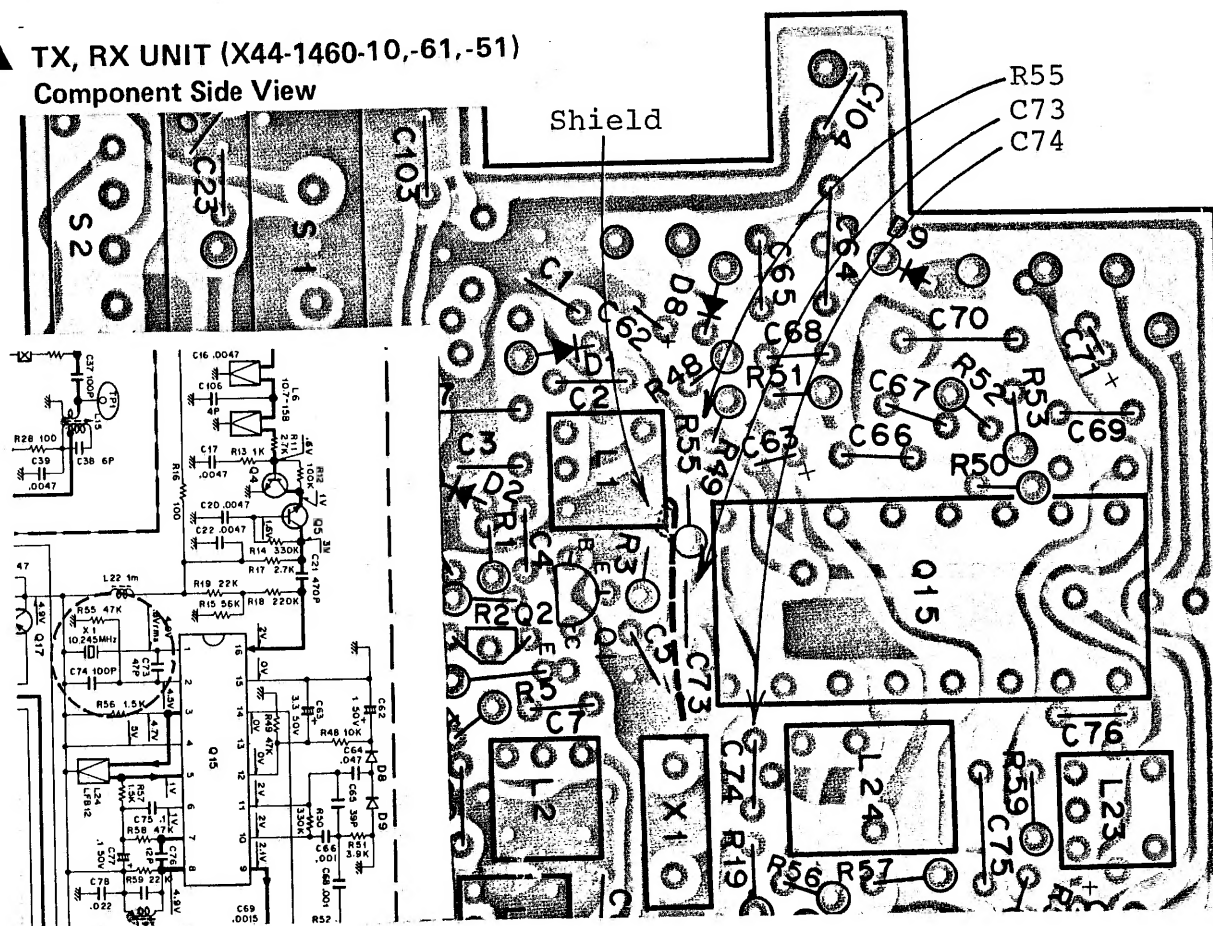
▲ TX, RX UNIT (X44-1460-10,-61,-51)

RX intermodulation distortion may be improved by reducing second conversion oscillator harmonic content and level. No adjustments are required. This may be applied to a unit specifically exhibiting out-of-band intermodulation distortion. It is, however, not a general improvement.

On the TX RX unit X44-1460-xx, perform the following changes;

R55 from 47k Ω delete
C73 47pf to 33pf (CC45SL1H330J)
C74 100pf 150pf (CC45SL1H151J)

Add a shield between Q1, (R3,C5) and C73 (from L1 to near X1).
